NATIONAL PROGRAM FOR INSPECTION OF NON-FEDERAL DAMS
FLAT RIVER RESERVOIR..(U) CORPS OF ENGINEERS WALTHAM MA
NEW ENGLAND DIV FEB 81

4. TITLE (and Subtitle) Flat River Reservoir Dam NATIONAL PROGRAM FOR INSPECTION OF NON-FEDERAL DAMS		5. TYPE OF REPORT & PERIOD COVERED INSPECTION REPORT

Based on a visual inspection of the site, the main dam embankment and appurtenances are considered to be in FAIR condition. The earth dike comprising the right portion of the dam, however, is considered to be in VERY POOR condition due to serious seepage problems which could lead to a piping failure.

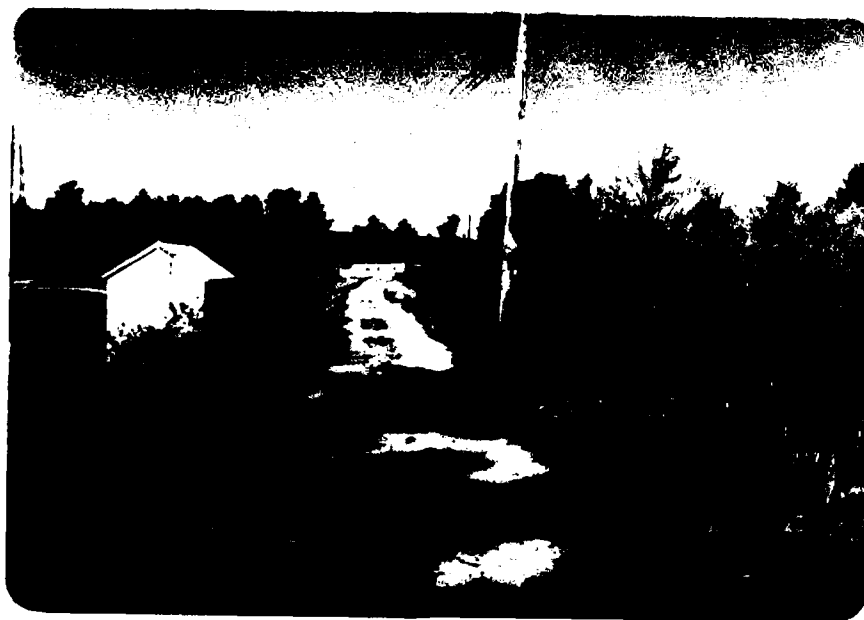
- b. Crest. The crest of the main embankment (Photo C-5) is gravel covered and approximately 13 feet wide. Minor erosion was observed at several locations along the crest. No lateral movement or misalignment was observed. The concrete core wall does not extend to the crest and is not observable.
- c. Downstream Face and Toe. The downstream face is an earth slope. The slope and toe are heavily covered with brush and trees. Several areas of minor erosion were observed along the top of the downstream slope. Thick brush, trees, and piles of cut brush obscured the lower slope and made it difficult to detect any seepage or other irregularities. Most of the downstream toe was also difficult to inspect because of the thick brush. The ground in the area was mostly soft and wet and ponded water was observed from Station 3+35 to 3+95.

PHOTO C-5: Crest of dam embankment looking north and upstream gate house on left.

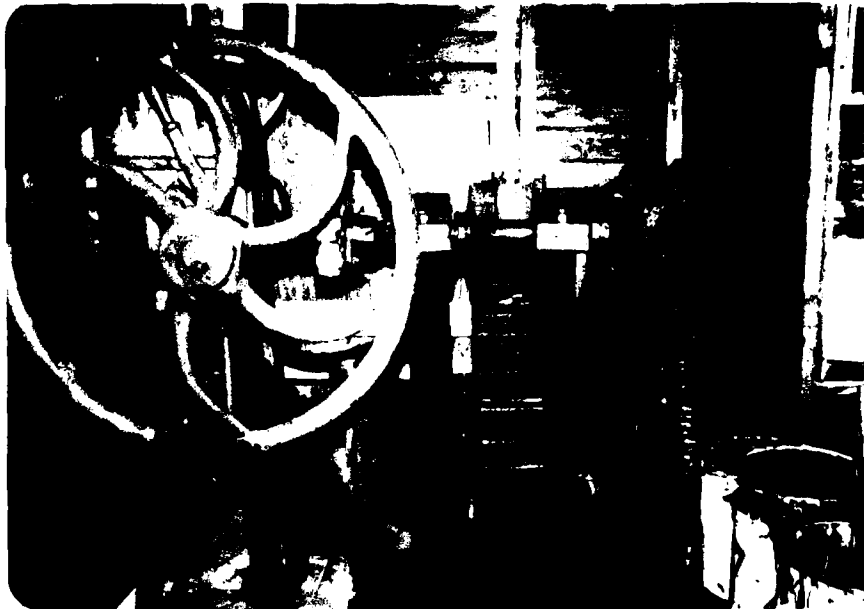
PHOTO C-13: Control mechanism for middle gate of intake structure.

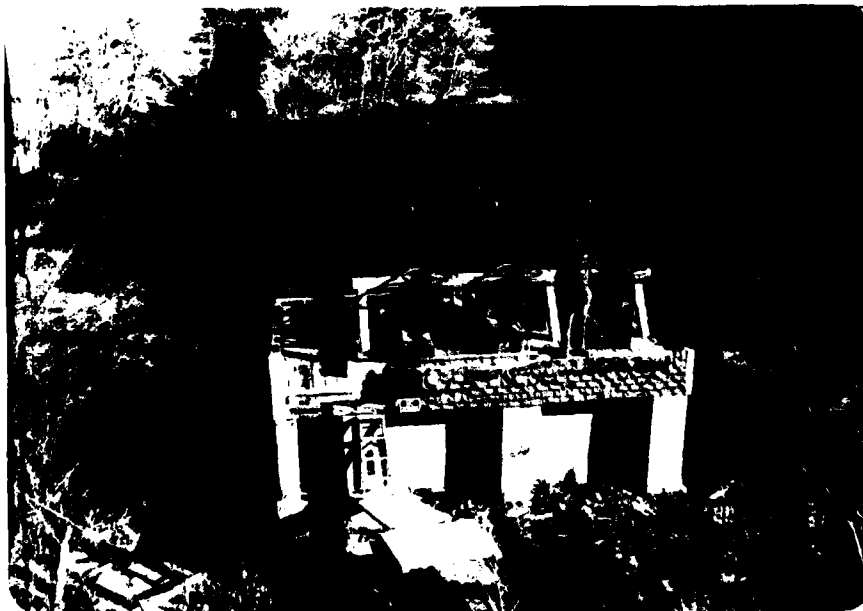
4. Outlet Structure and Gates. The outlet gate structure is located at the downstream toe of the dam (Photo C-14) and is in poor condition. Only the floor remains of the original wooden superstructure that housed the controls for the outlet gates. The wooden floor boards are rotted and unsupported on the right downstream side. Concrete on the downstream face of the outlet structure is spalled up to 3 inches into the face, and several cracks were observed in construction joints at the bottom of the structure. Access to the outlet structure is difficult. Loose plywood planking forms a crude bridge to the elevated structure and is in poor condition. An unanchored wooden step-ladder provides the only access to the control mechanisms for the outlet gates which are located at the downstream end of the outlet pipes. The left gate is inoperable. Just above the outlet gatehouse, each conduit has a short 48" diameter surge tank with a rotten wooden cover. Should the outlet gates be closed with the inlets open, the tank covers would be washed away by flow out of the top of the surge tanks. The outlet gatehouse cannot control outflow from the reservoir because of the condition of the surge tank covers.

PHOTO C-14: Outlet structure and downstream channel from crest of dam.

6. Further investigate the poor condition of the outlet gate structure and design the repairs or replacement necessary to restore it to an operable condition, if required.
